CAAC  
**适 航 指 令**

编号：CAD2016-F2TH-03

一. 标题： 防冰和排雨保护-发动机进气防冰系统-检查/修理

本指令适用于在中华人民共和国注册的所有制造序列号的Falcon 2000EX型飞机。

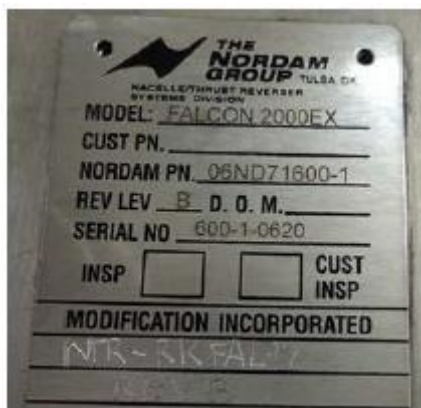
NRK : NTR-RKFAL97

注2：已经被翻修（使用NORDAM修理器材）的发动机进气道（P/N）06ND71600-1 符合了设计标准并在其进气道铭牌上标识了“NTR-RKFAL97”或“NTR-RKFAL98”。参见本指令Appendix 2中铭牌示例。
